South Saginaw Street Corridor Study

Prepared for:
City of Flint Planning Department
In Collaboration with:
Michigan State University Urban Planning Practicum

April 2013

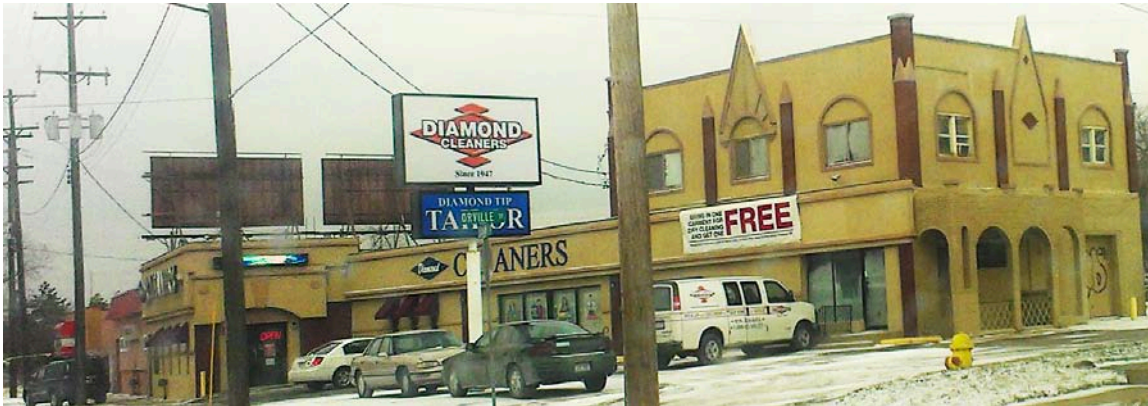
Figure 2.5: Example Building 1

Diamond Cleaners
2147 S Saginaw St

Good

1

The Diamond Cleaners property has been recently renovated, and has a unique, historic façade, good window conditions, a clean, well-kept lot, and a clearly marked sign for the business.

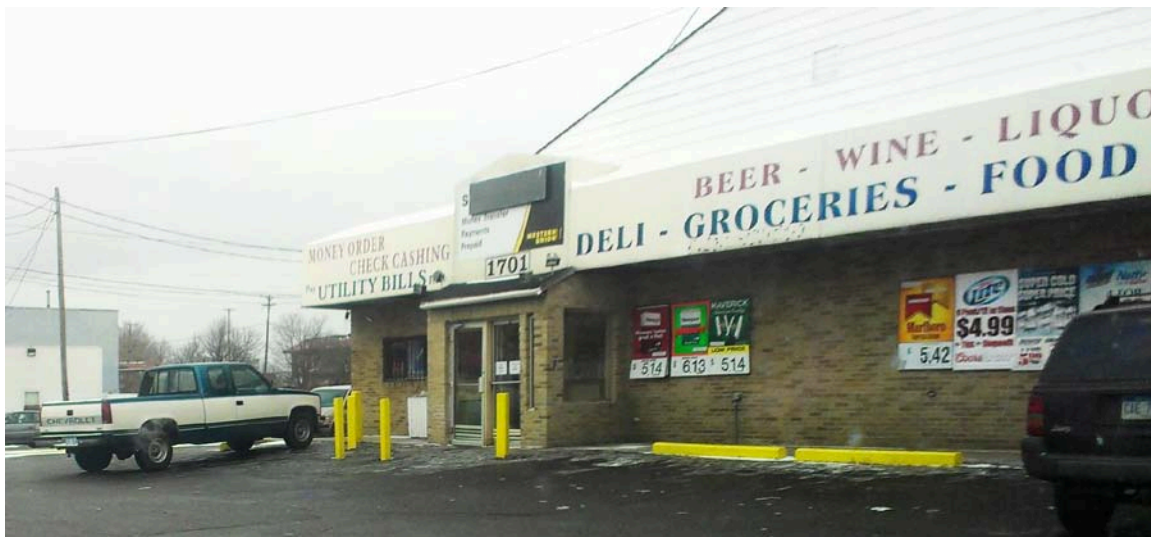
Figure 2.6: Example Building 2

Beer – Wine – Liquor
1701 S Saginaw St.

Fair

2

The liquor store located at the intersection of S. Saginaw Street and 12th Street exhibits an aged awning, minor cracks in the masonry, and a fairly plain façade, however it also is fairly well-maintained and has good window conditions.

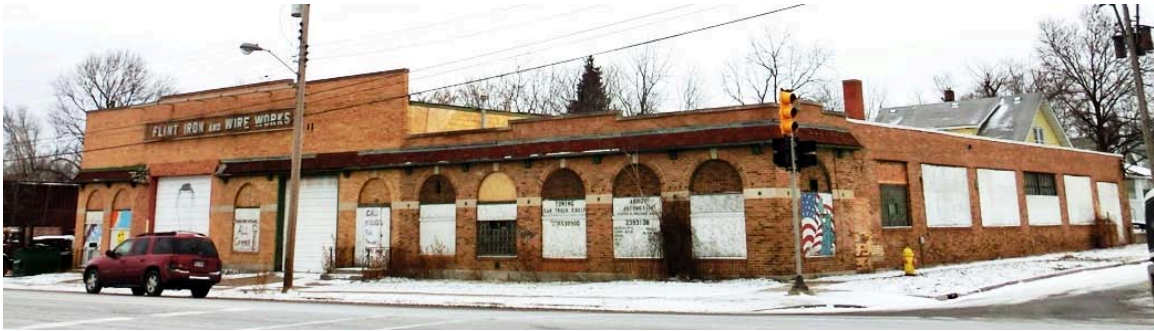
Figure 2.7: Example Building 3	Condition	Score	Assessment
Flint Iron and Wire Works 3205 S Saginaw St	Poor	3	It is unclear whether this industrial parcel is currently in operation, with a majority of the windows boarded up, some major cracks in the masonry, and a degraded historic façade gives this building a poor grade.

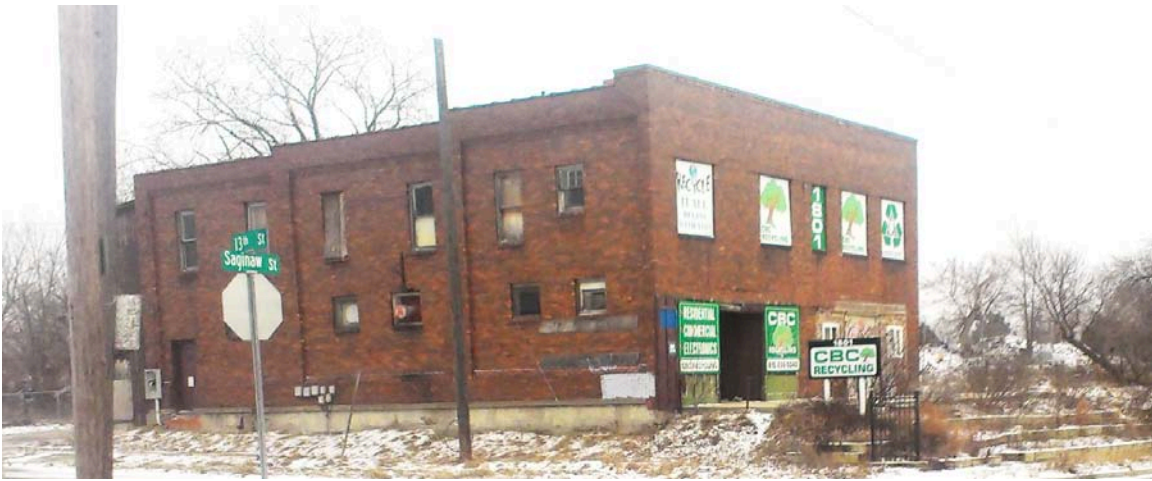
Figure 2.8: Example Building 4	Condition	Score	Assessment
CBC Recycling 1801 S Saginaw St	Structurally Deficient	4	CBC Recycling, located at 1801 S. Saginaw Street, received a score of 4, or structurally deficient, as there are major concerns with the structural integrity of the masonry, windows are either broken or boarded up, the building has visibly been vacant for a significant period of time, and the lot condition is dire, filled with thousands of pounds of recycling remnants, a hangover from the parcel's previous owner.

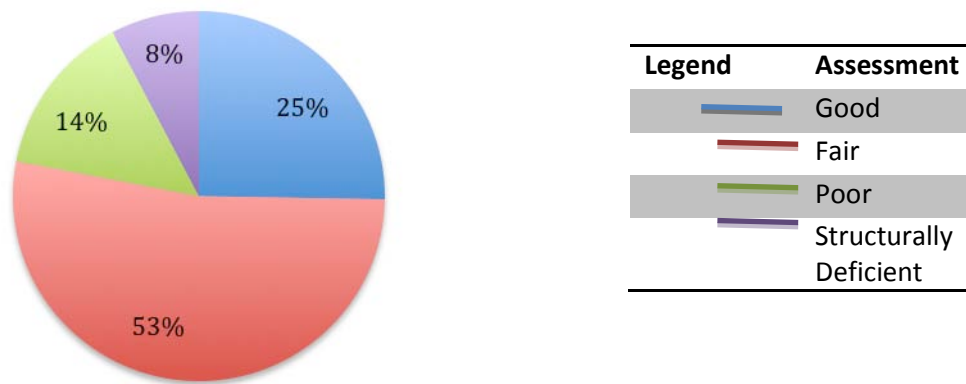
Figure 2.9: Commercial Building Scores

The research team examined 95 properties along the corridor, and assessed a score for each structure. A summary of each score's frequency is presented in Figure 2.9, while the full results appear in Appendix I. The average score for commercial structures along South Saginaw Street is 2.04, which indicates that the overall commercial stock on the corridor is Fair. This correlates with what researchers observed in the field, a large discrepancy in building condition, with freshly renovated properties that received the highest grade sharing a block with structurally deficient properties. This also aligns with the variance in condition displayed in the Housing Condition Survey (2012) conducted by the City's planning office.

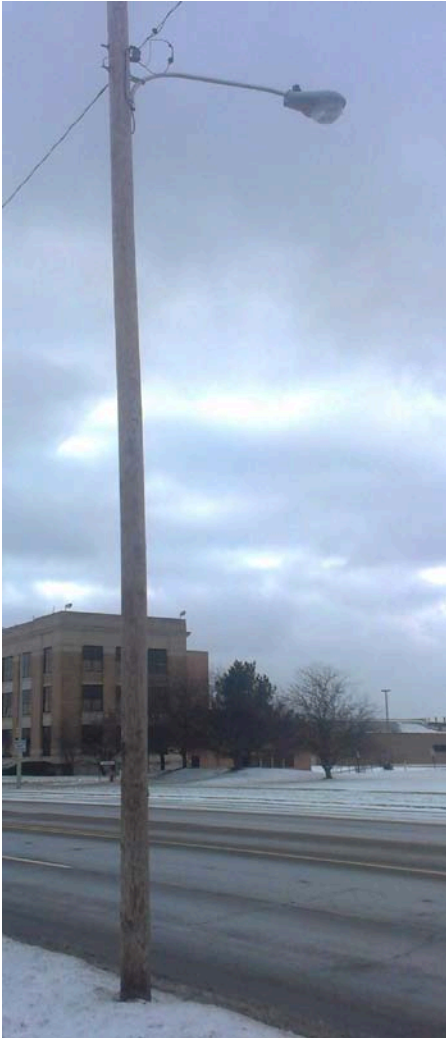
Figure 2.16: Example of Typical Streetlights along South Saginaw Street

The Street Lighting survey found that the lighting levels within the study area were fair, with an average score of 2.31. Most of the lighting was in functioning order, with adequate lighting found predominantly within the study area. However, while these lights are functional, they lack aesthetic appeal. The majority of the streetlights within the study area were mounted on telephone or utility poles, rather than metal light poles. This affected the general aesthetic score for the majority of the study area; however the southern-most blocks offer more aesthetically pleasing lighting fixtures on the western side of Saginaw Street. Conversely, the same low-ranking site detailed in the sidewalk condition report, the block directly under Interstate 475, again received the only deficient score. This block did not feature any lighting underneath the busy underpass, and lies directly adjacent to the charter academy. The street lighting conditions for each of the sections of the corridor are displayed in Figure 2.17.

- Remove deteriorating streetlights that do not uplift the character of the South Saginaw Corridor and replace them with lighting that build the character of the corridor.
- Safety of residents should be a major priority for city officials therefore; all street lighting should be well maintained in order to ensure safety.
- Work with city planners and other city officials to create a standardized system of streetlights that will be used throughout the corridor.

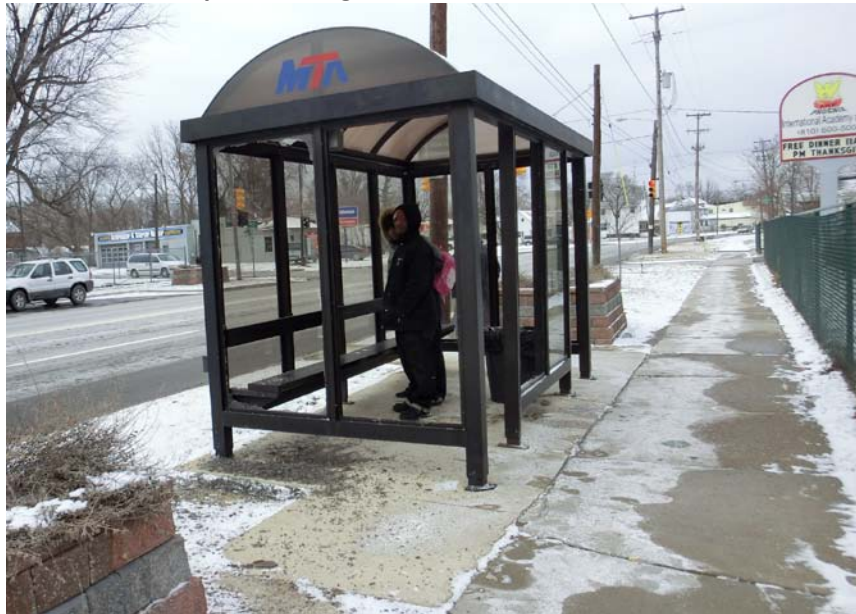
Figure 2.18: MTA Transit Stop, South Saginaw Street

Transit stops throughout the study area were generally without amenity. The bus stop located adjacent to the International Academy of Flint was the most well equipped transit stop within our study area. However, even this stop is not well maintained by the MTA, as it is missing numerous panes of glass and is generally dirty. Also, the transit stop does not include any route information, or additional seating outside of the shelter (Figure 2.18). This is typical of stops within the study area, as most were only distinguishable by small metal "MTA" signs attached to poles. This makes public transportation difficult for residents who are unfamiliar route schedules or directions.

- Bus stop shelters should be well maintained by the proper authority. Repairs should be expedited.
