THE SOUTHEND DISTRICT: VISION PLAN AND ECONOMIC DEVELOPMENT STRATEGY DEARBORN, MI

Yiran Chen, Christina Ignasiak, Melanie Nieske, Donald Whipp

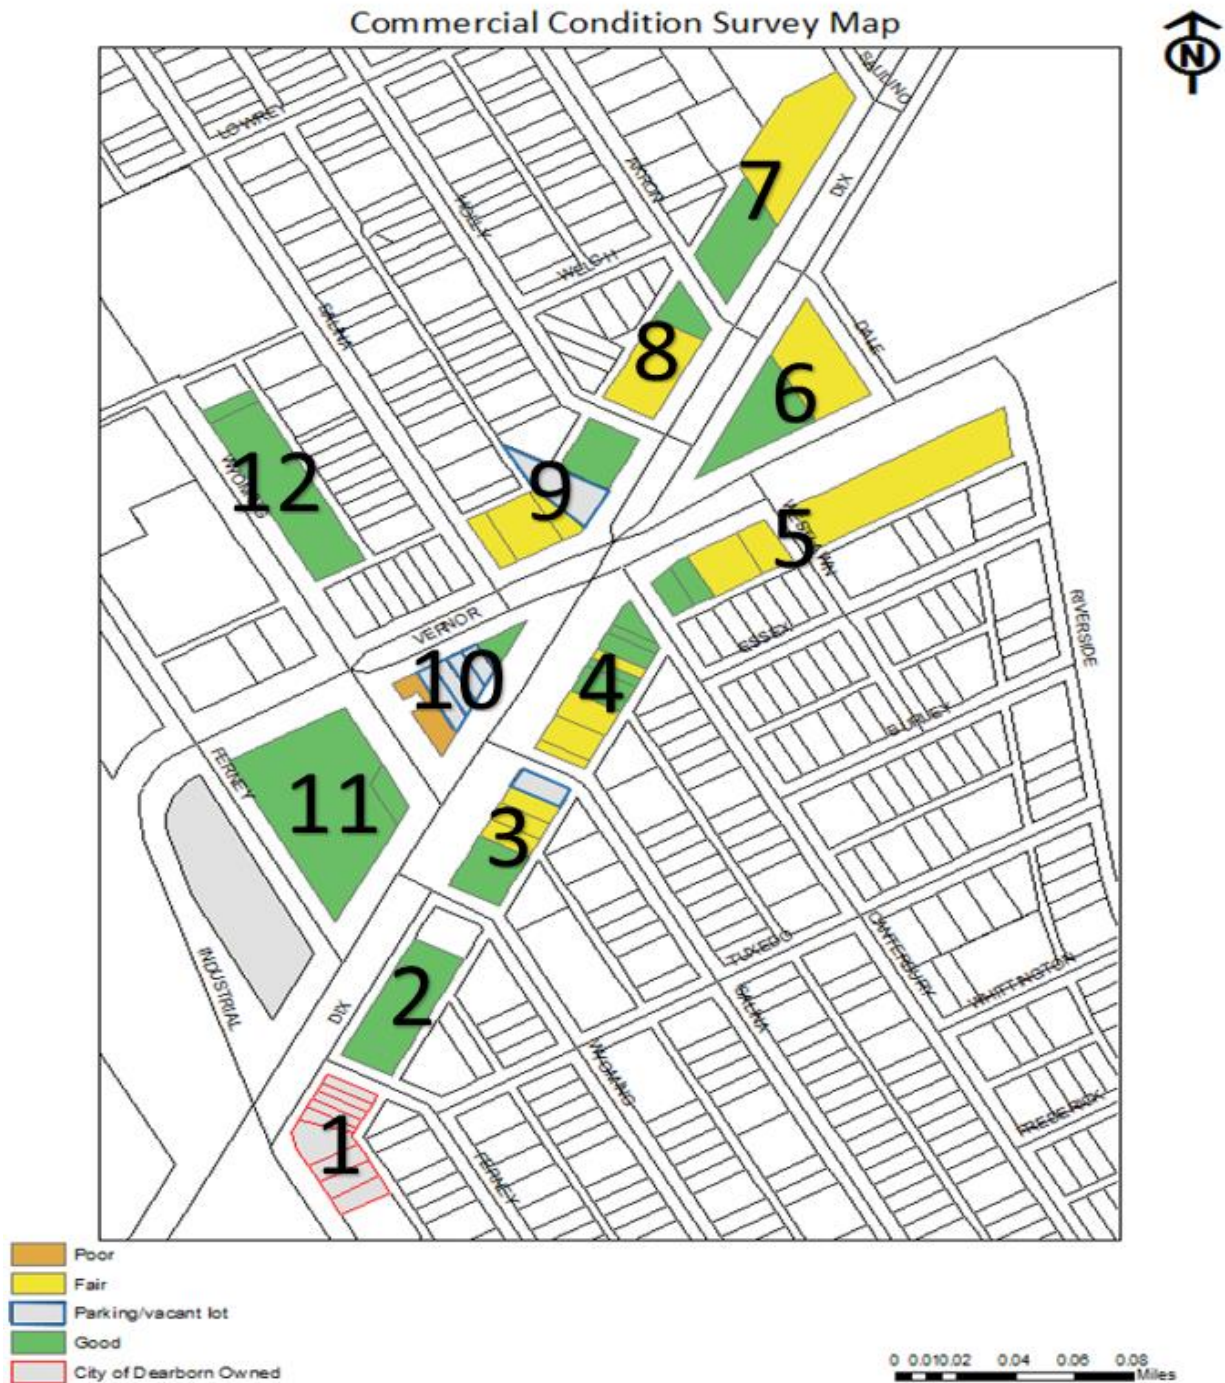
Figure 32: Commercial Condition Survey Map
(MSU Planning Practicum, 2016)

The Team created criteria to assess the condition of the commercial structures along the Dix-Vernor Corridor which was separated into blocks (the first block not containing structures) shown in Figure 32. The given characteristics that we have measured was the existing state of the business' windows, doors, siding, roof, the state of the paint or brick along the exterior of the business, lighting, the accessibility of parking, décor and greenery in front of the businesses, clear signage in front of each business, and the amount of setback from the street for each of the businesses. Our team has collected pictures along the corridor and sorted them by address as if one were walking from the north side to the south part of the district. Each commercial building was rated with conditions such as "Poor", "Fair", and "Good" based upon the criteria shown in Table 1. Each of the above criteria receives a score between 0 and 2 with a perfect score of 18. The unweighted scores between 0 and 5 signify a "Poor" score, the score between 6 and 12 signify "Fair", and a score between 13 and 18 signify a "Good" score.

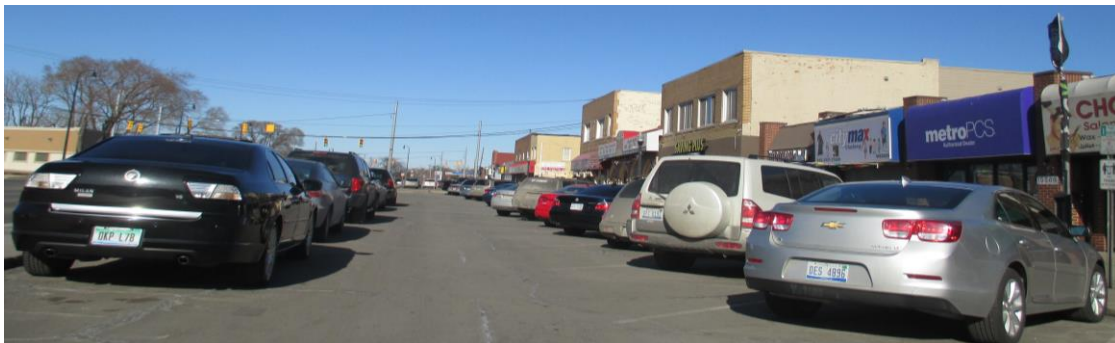
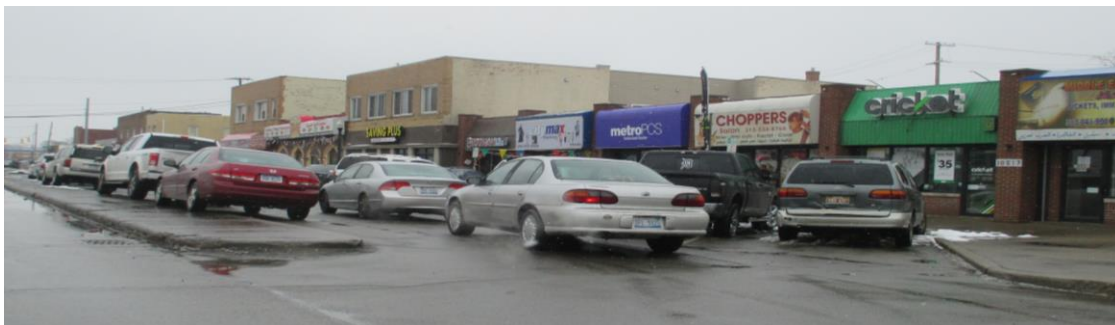
Figure 41: Block 3 Parking

A study was conducted to get a snapshot of the parking conditions located in 3 of the Blocks located in the Dix-Vernor commercial corridor. The parking was assessed in Block 3, 4, and part of 5 focusing on the commercial area and excluding the American Moslem Society Masjid. Vacant parking spaces were counted as well as photos taken at 30 minute intervals for 3 hours three different days Thursday, March 9, Friday, March 10 and Wednesday, March 14 at different times of day. This provides a comprehensive view of the parking conditions within the corridor. The City of Dearborn owns lots 160-163 which are located within the commercial corridor in Blocks 3, 4, and 5- the focus area within the corridor where the survey was conducted. As seen in the Tables 7 and 8 below, some figures in the "Percentage of occupied spots" column are over 100%. This is possible considering areas that are not marked as official parking spaces are utilized as overflow parking on the buffer curbs in the Blocks.

Parking: Block 3				
Date	Time	Occupied parking spots/Total cars in lot	Total parking spots	Percentage of occupied spots
3/5/2016	11:00am	9	18	50%
3/5/2016	11:30am	11	18	61%
3/5/2016	12:00pm	15	18	83%
3/5/2016	12:30pm	16	18	89%
3/5/2016	1:00pm	23	18	128%
3/5/2016	1:30pm	24	18	133%
2/11/2016	2:00pm	21	18	117%
2/11/2016	2:30pm	20	18	111%
2/11/2016	3:00pm	17	18	94%
2/11/2016	3:30pm	14	18	78%
2/11/2016	4:00pm	14	18	78%
2/11/2016	4:30pm	15	18	83%
3/30/2016	5:15pm	18	18	100%
3/30/2016	5:45pm	17	18	94%
3/30/2016	6:15pm	19	18	105%

At various times of the day, there is a surplus of cars parked illegally in the three different blocks that have been studied. Block 3 during many times of the day has percentages that are well above 100% occupancy because of the cars that are parked illegally on the overlying curb in front of the businesses. Block 4 has a surplus of cars during the afternoon as well with a percentage well above what the parking lot has designated for spots. Through the research conducted, it was found that the times where the parking spaces are most utilized are in the afternoon from about 1:00pm-2:30pm and in the evening from about 5:15pm-6:15pm.

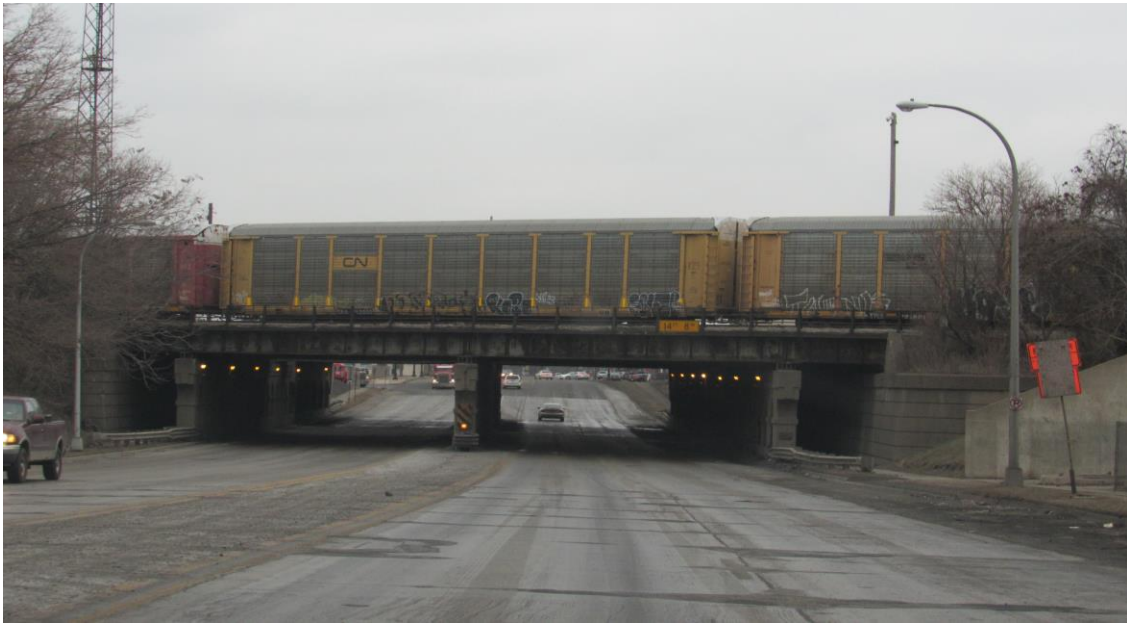
Figure 49: Dix-Vernor Corridor Viaduct

- **Welcome Signs:** Welcome signs serve as a way to promote an area by reflecting your presence to visitors and residents alike. Figure 48 shows an example for Auburn Hills, MI, where a welcome sign was utilized to create a sense of place and signify the presence of the community. The entrance viaduct to the corridor, Figure 49, would benefit from a welcome sign. This would assist in creating a sense of pride for business owners and residents, and a sense of awareness for visitors to the corridor. Other signs strategically placed around the corridor for maximum saturation would also be beneficial.

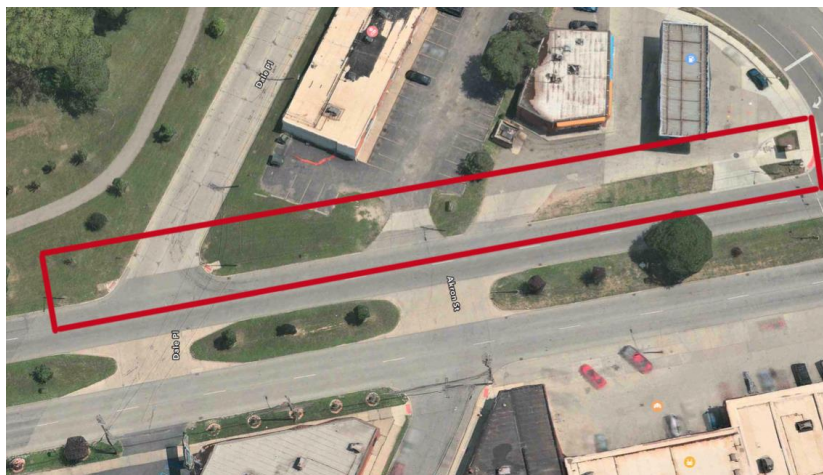
Figure 51: Block 6 Sidewalk Connection

- Focus on implementing continuous sidewalks, without breaks or abrupt endings. Continuous sidewalks encourage use and make conditions safer for pedestrians and bicyclists. Where it is possible, sidewalks should be on both sides of the street so pedestrians do not have to walk in the street or cross twice. An area that would benefit from a continuous sidewalk is located in Block 6, shown below in Figure 51.

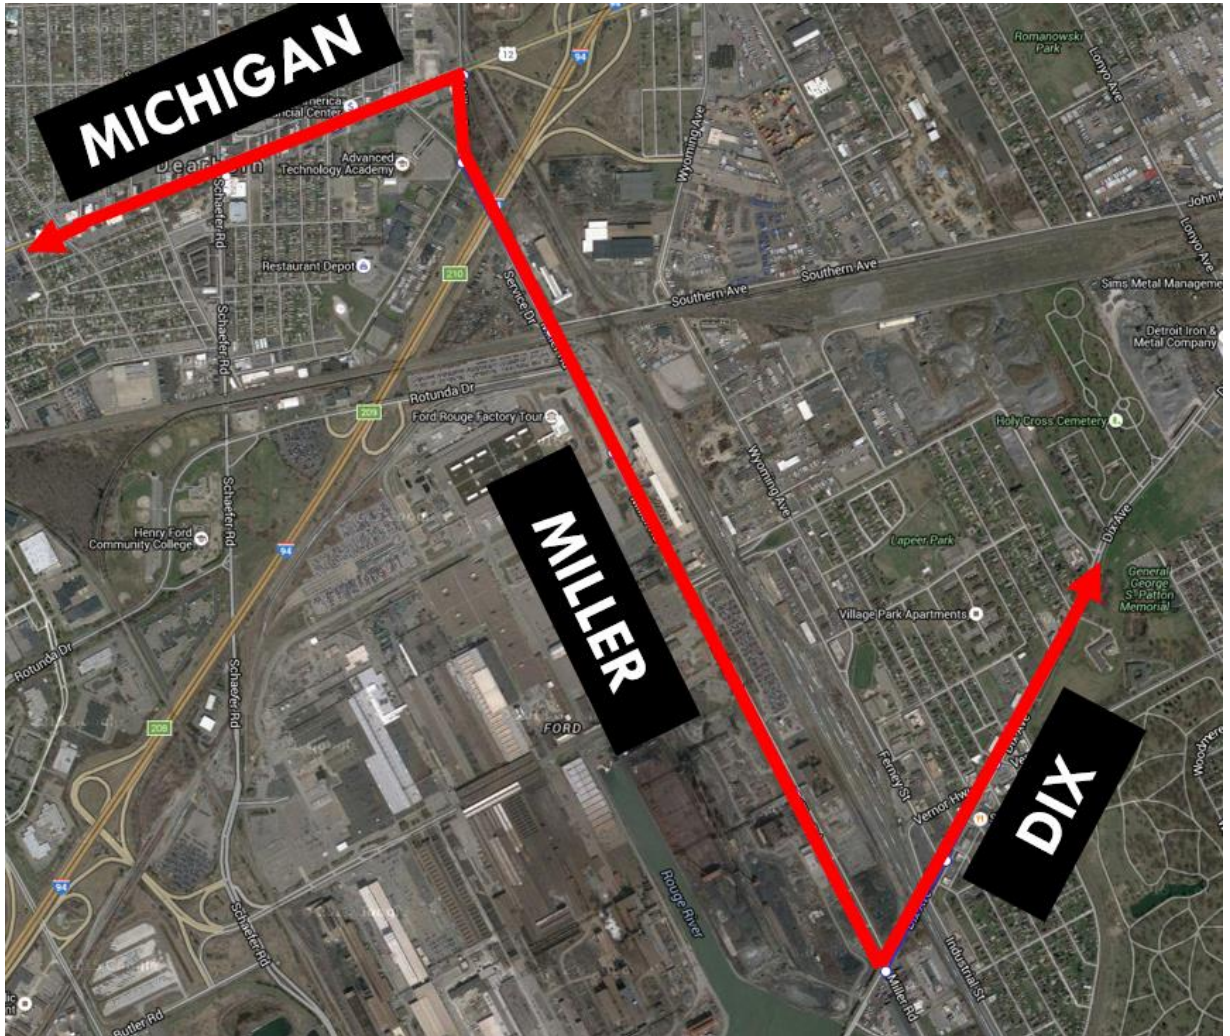
Figure 52: Potential Southend Bike Route

- The addition of biking within a community provides economic, social, health, safety, and environmental components that assist in improving the quality of life for the area. In conjunction with the work the City of Dearborn is already working on in regards to a bike route, the DVBDIA should conduct further research to connect a bike route from Southwest Detroit, The Southend,

and Michigan Avenue in Dearborn. The route within The Southend could travel from Dix to Miller Road to Michigan Avenue. After the designated connecting bike route is created, designate the established bike lanes with painted street markings.

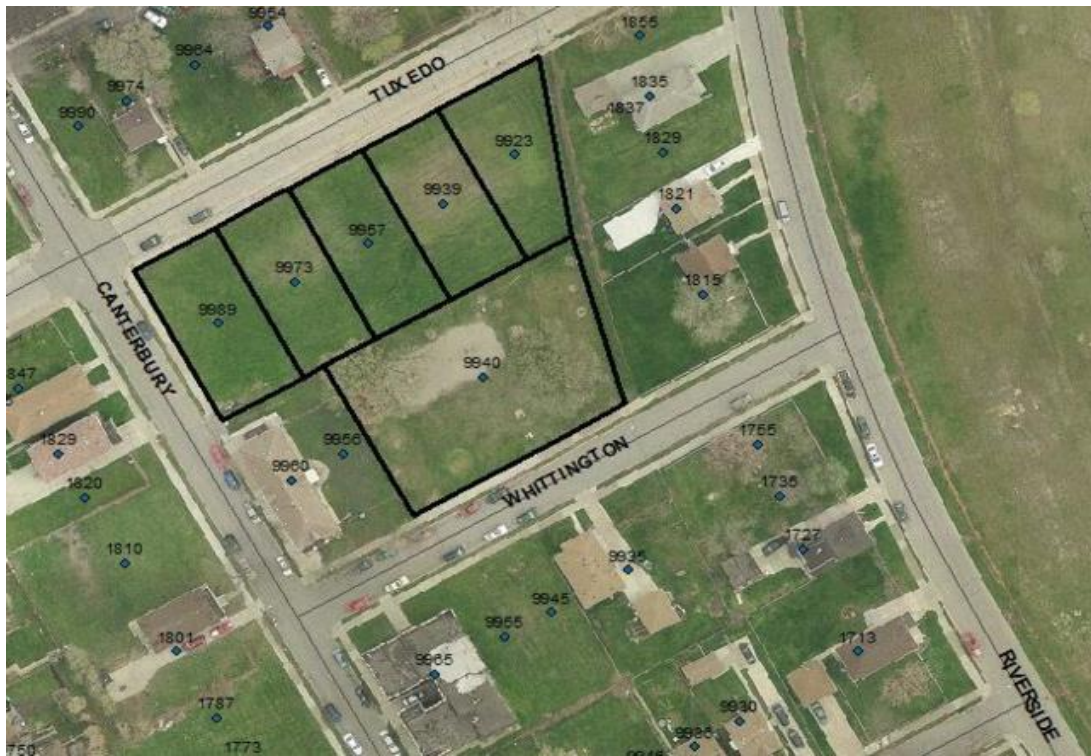
Figure 53: City Owned Park Parcels

- The current city owned parcels, 9989, 9973, 9957, 9939, 9923, and 9940 shown in figure 53 located between Tuxedo, Whittington, Riverside, and Canterbury should be improved. Improvements including removal of current play structure on parcel 9940 poses potential safety concerns for users, clear entrance/exits, and walk ways. These improvements will enhance the general access of the mentioned areas.

- The addition of raised beds on parcel 9940 to initiate the community gardening project. A partnership between the park and ACCESS could stem around the community gardening initiative in order to create a space where residents of the community could have garden space and cultivate fresh, healthy food.
- Park should be equipped with a sign and logo to parallel with the branding initiative of the district. This will unify the community and strengthen the sense of place making it clear to residents and visitors alike that this park is in The Southend. There should be a separate sign for the community garden area and the park area and the signs should be placed at the entrance points, on parcels 9940 and 9957.

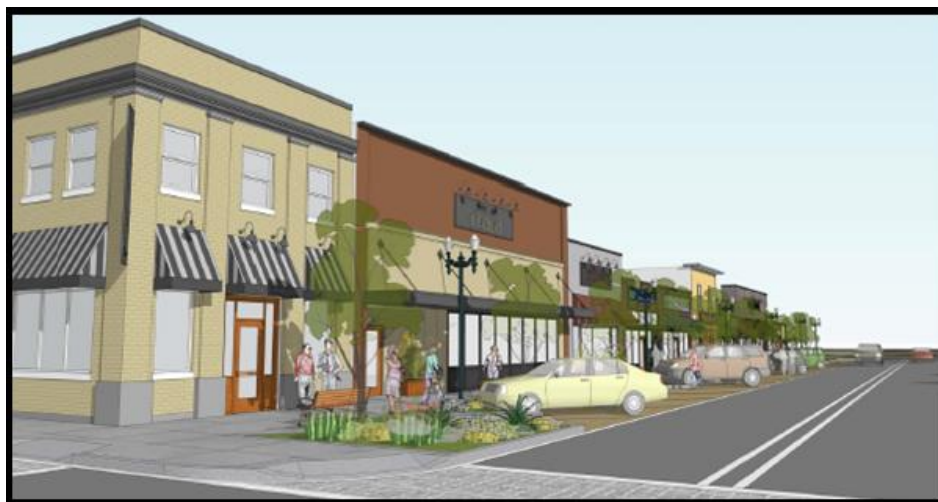
Figure 56: Facade Rendering Example (Estacada Development Association, 2016)

Improving the conditions of these commercial structures in the corridor will create a strong of sense place and pride for businesses owners as well as residents of the area. An example of a façade with proper lighting, bricks/painting, windows, doors, greenery/décor, and signage is reflected in the rendering in Figure 56.

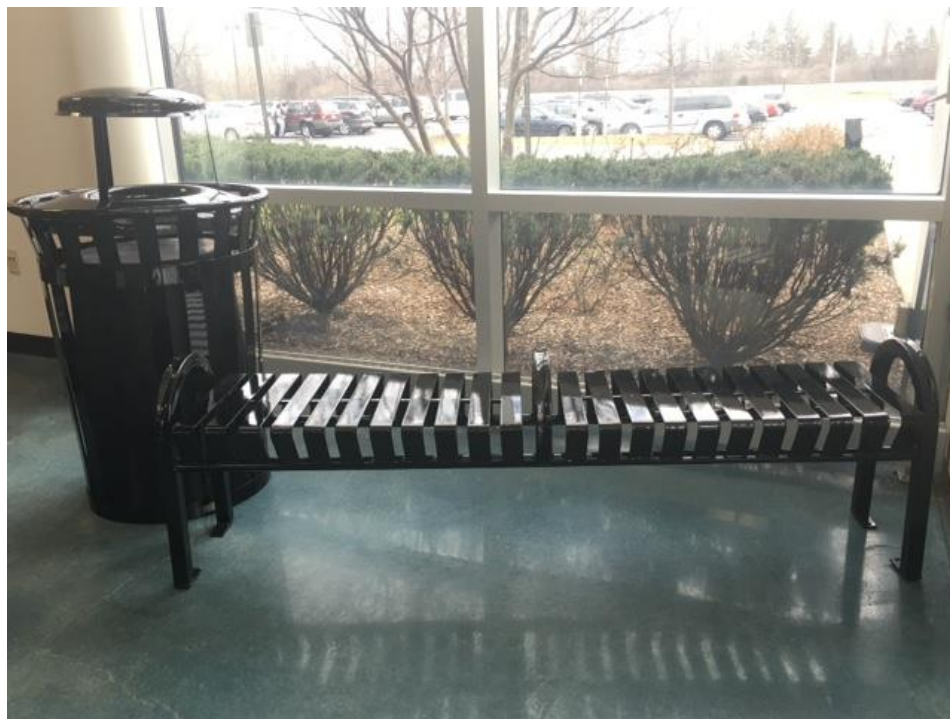
Figure 60: Benches and Garbage Cans for Dix-Vernor Corridor

The City of Dearborn has purchased benches and garbage cans to be located in the Dix-Vernor corridor (Figure 60). The Team has recommendations for appropriate locations for these items within the corridor that will impact the economic development and overall sense of place in the community shown in Figure 61.

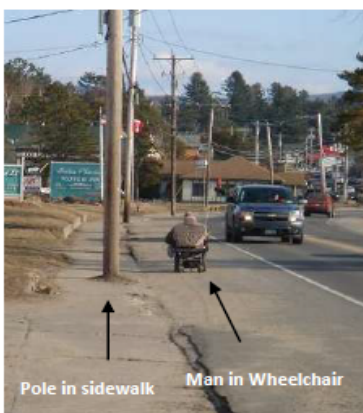
Photo 1

Sidewalks – to the right is a picture of an ideal sidewalk (Figure 1) in a highly trafficked area (perhaps the main street of your community). The **Frontage zone** should be at least 2ft wide to leave space for opening doors. The **Sidewalk** itself should be a **minimum of 4ft wide**. The

Furniture Zone (sometimes called the buffer zone) should be 4ft wide. The Furniture Zone is not required but it provides a barrier between pedestrians and motorists as well as a location for telephone poles, garbage cans etc... (NYSDOT)

Many streets in your community are probably less traveled and will not necessarily have a Furniture Zone or a frontage zone which is OK. However, it is important to still be aware of **obstacles** in the sidewalk which would make it difficult for someone with a disability to get around, such as telephone poles (i.e. photo 1). Sidewalks should have at least 4ft of navigable space clear of obstacles (NYSDOT). Also note the maintenance of the sidewalk in photo 1. Sidewalks with cracks and holes or covered in dirt will be harder to navigate

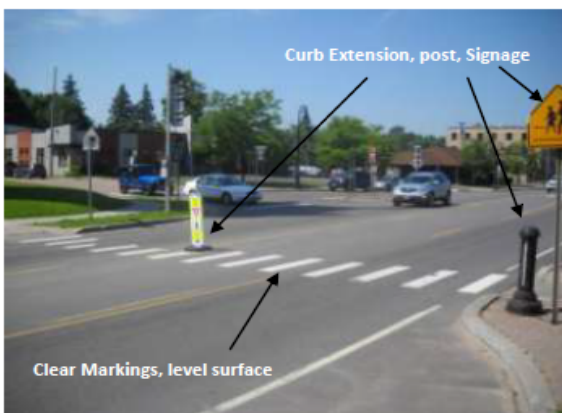
Photo 2 exhibits many of the desirable elements of a crosswalk. Crosswalks should have **curb ramps** on both ends. Crosswalks should also be well marked with **signage** on the side of the road and if necessary in the middle of the road.

If the road is very wide an island might also be appropriate. Also, notice how the curb ramp on the right is extended from the sidewalk and has a concrete post at the end of it. This protects the pedestrian and allows them to see and be seen farther down the road. The **painted markings** on a crosswalk should also be clear and distinct and the crosswalk surface should be **smooth and level**. If it is a busy intersection the crosswalk may also have a Crossing Signal.

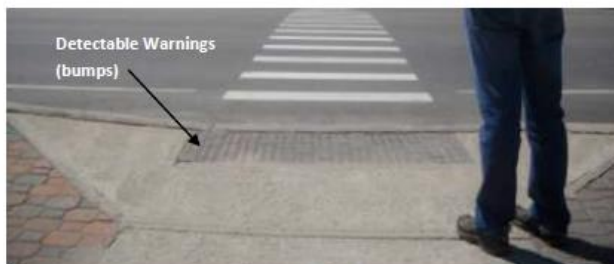
Photo 3 shows an acceptable ramp. It has a gentle slope with flared sides and Detectable warnings (bumps) for the vision impaired. **CAUTION:** This ramp has a problem. Notice how the curb at the end of this ramp is slightly higher than the ramp. **Ramps should be flush with the road.** Also, check for wear on detectable warnings, they are often worn flat and need replacing.

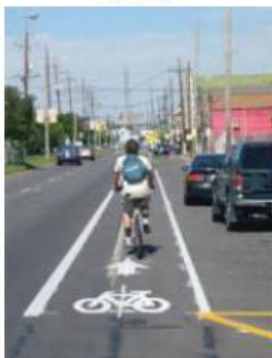
Photo 4

Signage - Lastly, areas with heavy traffic or many bicyclists should have plenty of signage. The NYSDOT requires **striping** for an official bike lane and recommends some sort of **painted marking in the lane** as seen in photo 4. ANY area which bicyclists or pedestrians may use whether it's a rural road or a busy main street can benefit from **increased signage**, some possible signage is shown in Figure 5 .

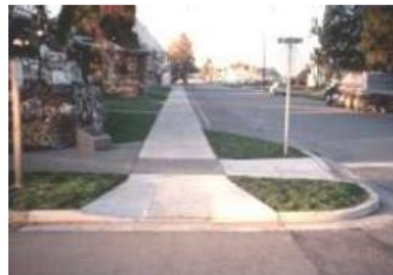
Photo 1

Curb Extensions – (photo 1) Curb extensions are where a sidewalk juts out into the street to provide access to a crosswalk. Curb extensions serve a dual purpose. First, they slow traffic down by narrowing the roadway. Second, they allow the pedestrian to get out into the street where they can better see oncoming traffic and oncoming traffic can better see them before they step into the roadway.

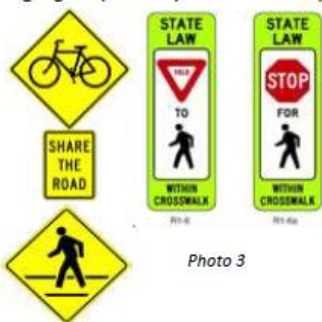
Photo 3

Signage – (Photo 3) There are many different types of signage you can add to a roadway. Share the road, pedestrian crossing, school zone and walk to school zone to name a few. Signage helps raise motorist's awareness of pedestrians and bicyclists regardless of the location.

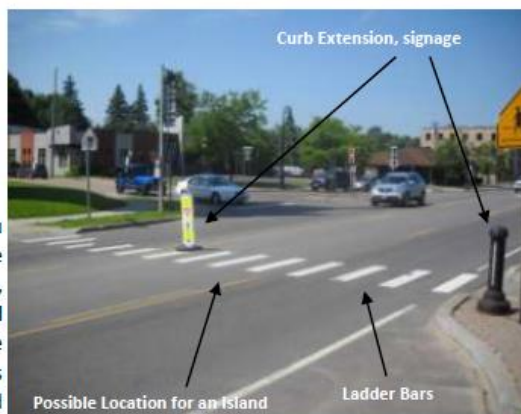
Signalized Crossing - countdowns, sounds – (photo 5) Busy intersections may also have crossing signals, to make signals useful for people of all abilities they should contain an auditory signal for the vision impaired as well as a countdown timer so pedestrians know how much time they have to cross.
